## STATUS AND REBUILD: MY NV5600

As was discussed in Issue 64, page 85, there are a lot of New Venture NV5600 six-speed transmissions in service, with these being used from 1999 through 2005. As they get more miles on them, especially under heavy towing conditions, the need for rebuilders has grown accordingly. This transmission is far more complex and heavy than the older NV4500 five-speed, as was outlined in Issue 64. This stout transmission has excellent ratios for our Turbo Diesels (5.63, 3.38, 2.04, 1.39, 1.00, and 0.73 forward gears, and 5.63 reverse ratio). Some owners are reporting problems with them, especially at or beyond about 150,000 miles. Some owners feel that overfilling with one to three quarts of lubricant in addition to the factory specification of about 4.2 quarts helps longevity, due to better oiling of the rear bearing. Various failures have been reported, and if the rear bearing seizes, the owner often continues driving, and reports later that the transmission “freed up” soon after experiencing “drag.” In these cases, the bearing is welded to the outer race, which then spun in the main case. The case can be salvaged with a precision machined hole and a speci

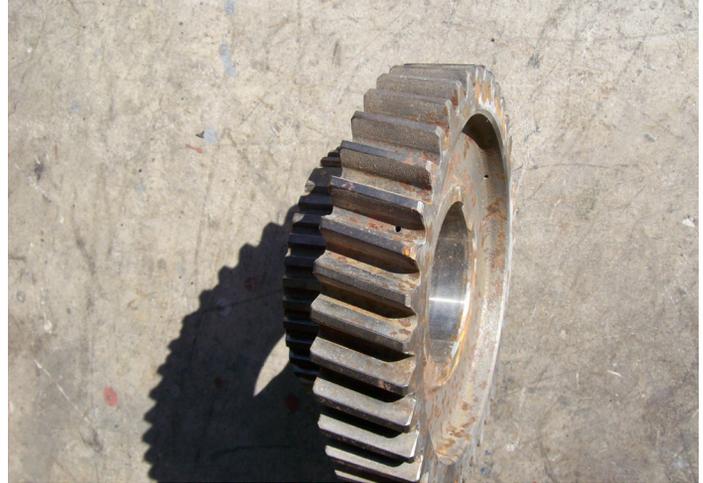
OEM positive lubrication for a mainshaft bearing—precursor to the Power Lube Package from Standard Transmission and Gear.

Standard Transmission and Gear just released their “Power Lube Package” to increase lubrication in critical areas of the NV5600 as well as to increase lubrication capacity. The former upgrade is performed by drilling first gear to force lubricant to the rear bearing in the main case. This is the bearing most prone to failure from lack of lubrication, and is the major reason many people overfill the NV5600 six-speed transmission by as much as three quarts as I mentioned previously. While it is desirable to raise the lube level somewhat over stock, the real solution to the problem, as developed by Standard Transmission and Gear, involves adding lube “spit holes” to the gear, similar to what has been done over the decades in other transmissions by the manufacturers. The size and placement of the holes going from the roots of several teeth to the inside “pocket” around the adjacent shaft bearing is critical, and without giving away proprietary information, I can say that the holes in the gear shown in this picture are NOT the same size as what Standard Transmission has found to work well in the NV5600s.

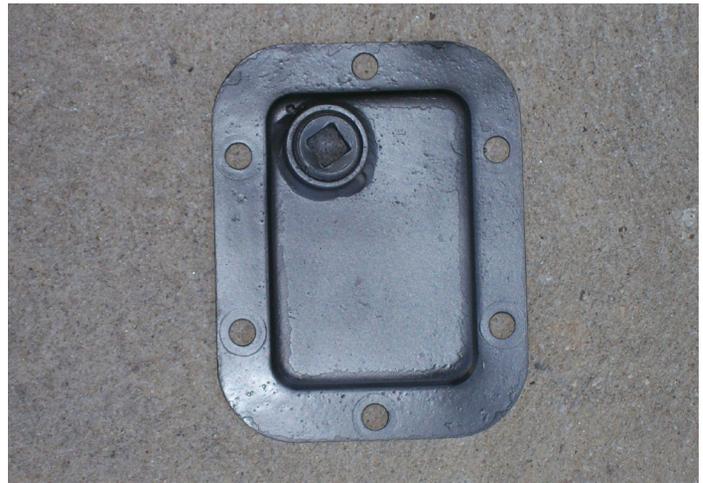
PTO cover with fill plug to facilitate adding more than four quarts of lube to the NV5600.

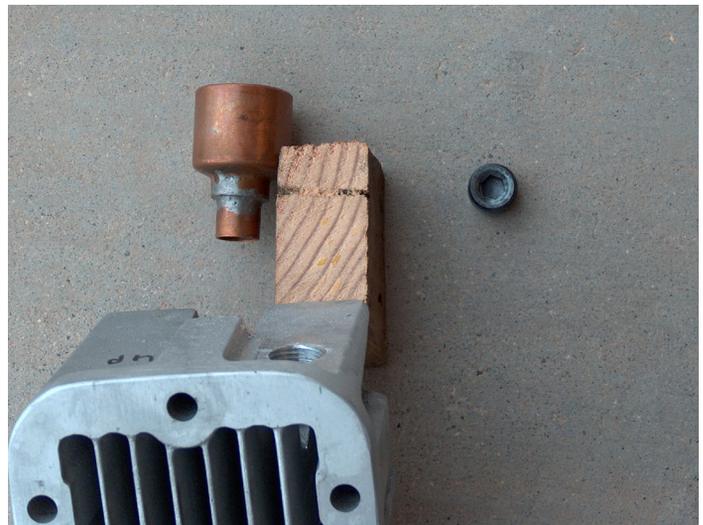
Modification to the Trans Cooler to allow filling from the top of the cooler. I used this orifice to put 6.3 quarts into my NV5600, and more could probably be poured in from there.

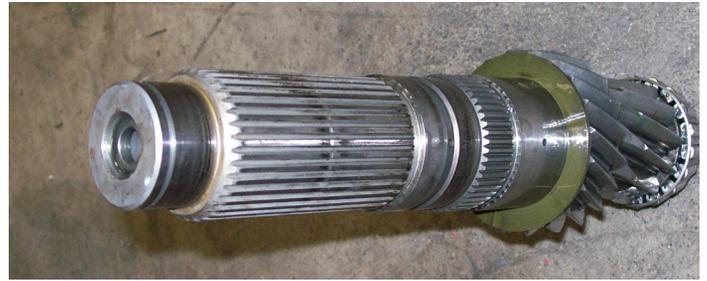
Upon disassembly Noe’ showed me another issue. The countershaft (cluster shaft) has an oil hole drilled through it lengthwise with “spit” holes to lubricate bearings on the shaft. The holes are very small and could be plugged by debris, resulting in failed bearings.

NV5600 countershaft showing oiling passages.

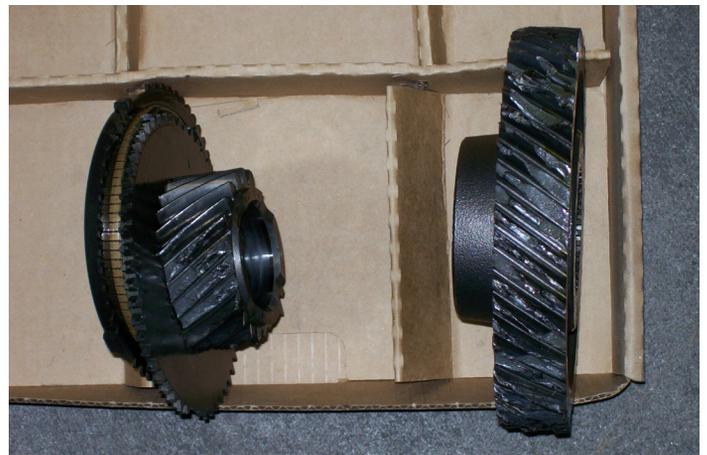
Richard showed me two major failures with the NV5600. In one case, the owner was hot-shooting with very heavy trailers, towing in sixth gear (overdrive) for long trips that got the transmission very hot. Sixth gear failed, with gear teeth broken on both the main shaft and counter shaft gears.

Broken sixth gears from overloading.

Note that overdrive gears aren’t very large, so their strength is limited and more heat builds up on individual teeth as they rotate more frequently. The other failure was the rear bearing in the main case This is the bearing that gets starved for oil in a stock NV5600 and that the Power Lube Package floods with oil, even when the lube level is below four quarts, as one of Standard’s customers unfortunately found out by running only about one quart of lube inadvertently in his recently upgraded transmission. About the only bearing that survived was the rear bearing on the main shaft!

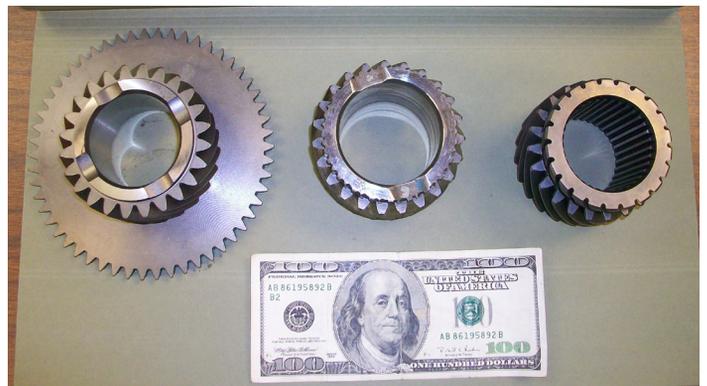
Sizes of overdrive gears. At left, NV5600; center, G56; right, NV4500. At the bottom is a fine engraving of my favorite American!

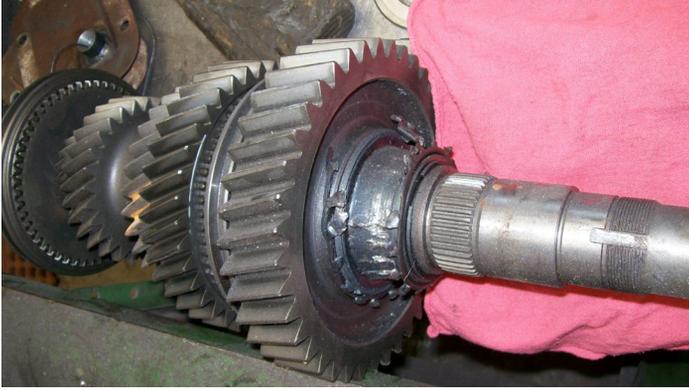
Melted first gear main shaft bearing from heavy loading, insufficient lube, and no Power Lube Package.

Second, I was impressed by the elegance of the Power Lube Package. Again, Charlie told me about the failure from insufficient lube where only the bearing protected by Power Lube survived undamaged. He told me about the development work they performed to optimize the modification. I feel that the cost of this upgrade is well worthwhile for all NV5600s and critical for heavy towing.

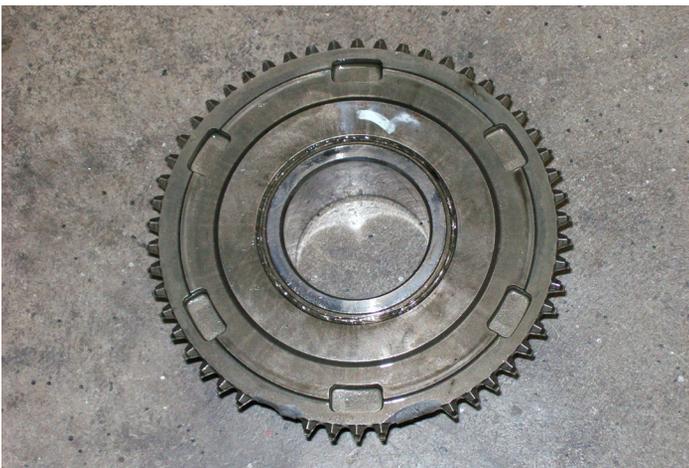
Noe' Lopez and Richard Poels disassembled my transmission and subjected the components to the cleaning and inspection processes. Several problems were evident. First, several synchronizer teeth were broken off sixth gear.

Sixth gear synchronizer with several missing teeth.

Richard said that I hadn't caused this failure and that the synchronizer would still work adequately. Of more concern were the broken teeth which we found in the bottom of the gear case. To perform a complete rebuild, we replaced the gear and synchronizer assembly. Second, the wear pattern on the input gear suggested the main shaft clearance was too high as set by the factory. This assessment was reinforced by the odd wear pattern on several outer bearing races. Most brass synchronizers were about half worn and none showed erosion from the use of the Torco GL-6 lubricant. However, when I was having clutch disengagement problems caused by a worn hydraulic system and clutch dust buildup within the pressure plate, I had to "force" the transmission into first or reverse gear sometimes. Those synchronizers were much more worn and the teeth on the outer sleeve of the reverse synchronizer were worn. Fortunately, this sleeve is reversible so we could turn it around and use the other side rather than replacing it. That sleeve is used only for reverse, but is machined on both sides as are the other three sleeves that are each used for two gears: 1-2; 3-4; and 5-6. The bearings were in pretty good shape except that they had caught a bit of abrasive. A few pieces of embedded metal could be seen in outer races, and they had a somewhat "frosted" appearance from abrasives. Therefore, a bearing kit and a synchronizer kit were used in the rebuild.

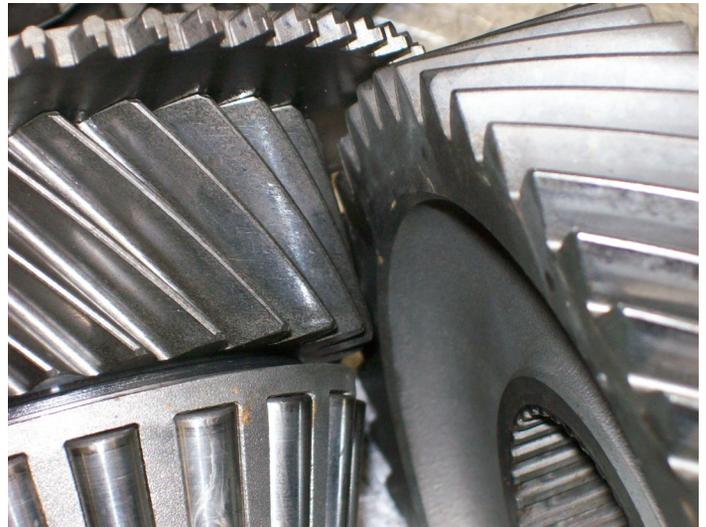
Wear patterns on gears from loose factory set-up.

One very important consideration is that as the transmission gets hot during use, it grows in size. Therefore, exact and correct shimming of the end play for the main shaft and for the cluster shaft is critical for longevity. Through experience Standard Transmission has found what exact clearances are best, and I watched as they carefully set up my transmission.
