REBUILDING THE G56 SIX-SPEED TRANSMISSION

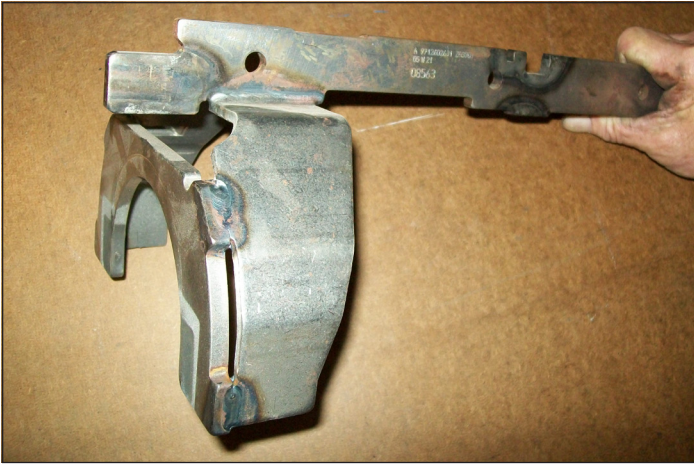
71-17 Heavy stamped steel shift fork with welds that are prone to failure.

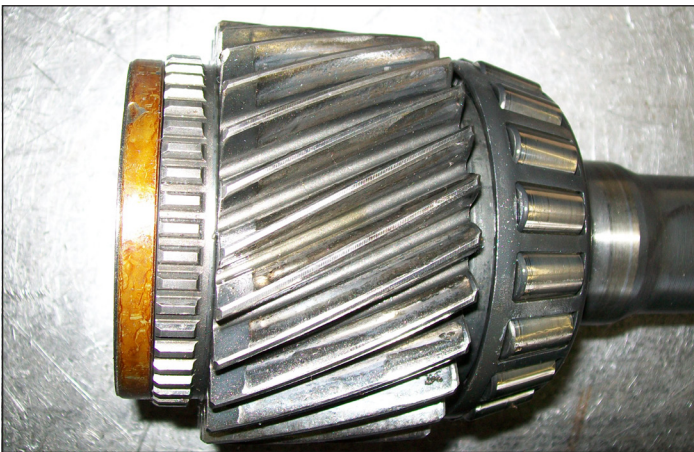
Standard often finds evidence of misalignment of the mainshaft gears versus the cluster gear, shown here on an input gear (photo 71-18). Broken gear teeth can result (photo 71-19). Wear patterns indicate that the teeth are spreading the transmission case, causing wobble in the input gear, and gear teeth are wearing closer to the edges of the teeth. Heavy loads then cause them to break.

71-18 Input with wear indicating misalignment of gears.

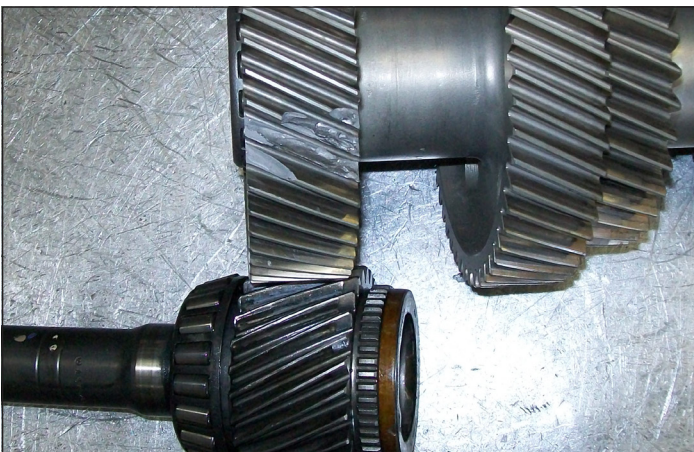
71-19 Input and cluster with broken teeth caused by poor alignment and heavy loading.

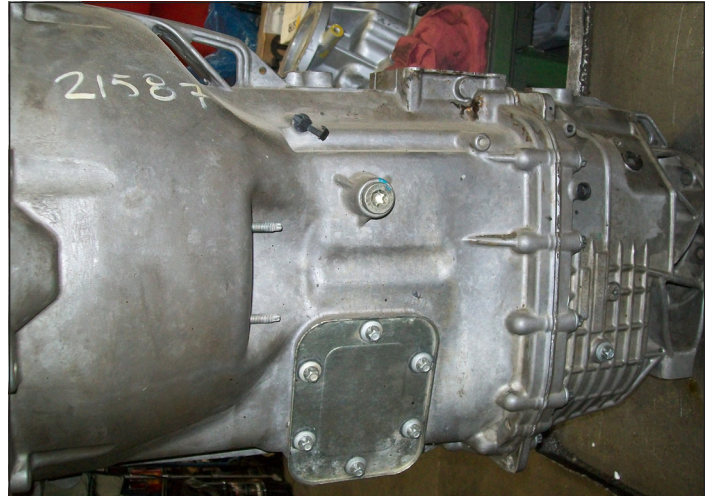
71-20 G56 two-piece transmission case.

It appears that the transmission case is irreversibly spreading lengthwise more at the mainshaft (top) than at the cluster. The mainshaft being two-piece, with an input gear separate from the rest of the mainshaft, contributes to the forces spreading the case, and brings about the excessive endplay seen in the mainshaft and sloppy sideplay felt when wiggling an input shaft side to side. This is a buckling or distortion and not merely dimensional growth with heat, although that growth is no doubt involved also. I brought up the idea of building a "girdle," possibly with load bolts to the top of the case, and Standard is looking into this modification in an effort to strengthen the G56 case which appears to be rather thin, inadequately reinforced at the top, and further weakened by being split cross-wise.

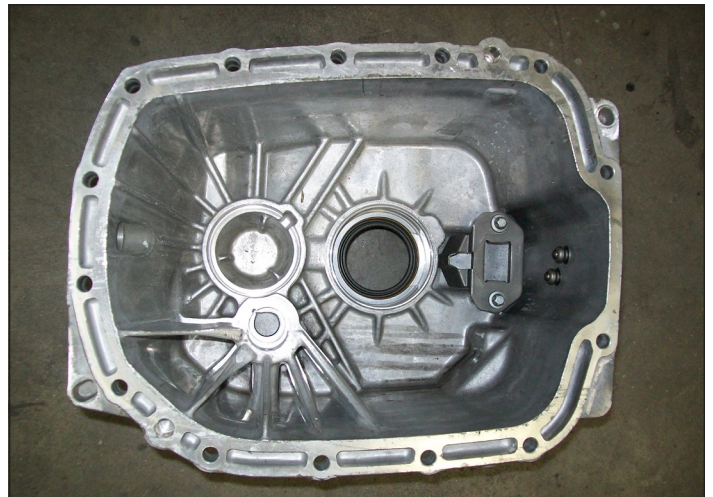
71-22 Rear half of G56 case viewed from the split at mid-case.

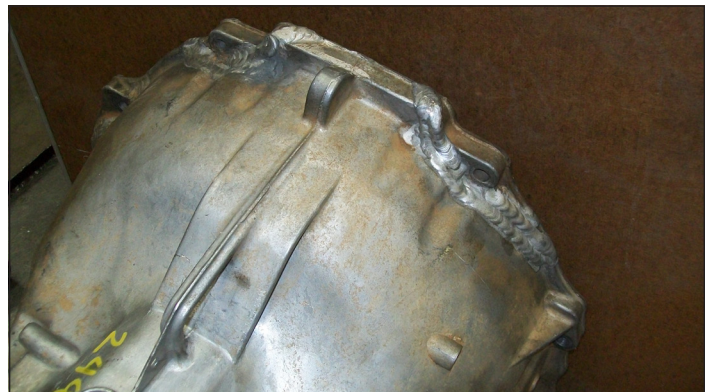
71-23 Welded but distorted G56 case at bell housing area.

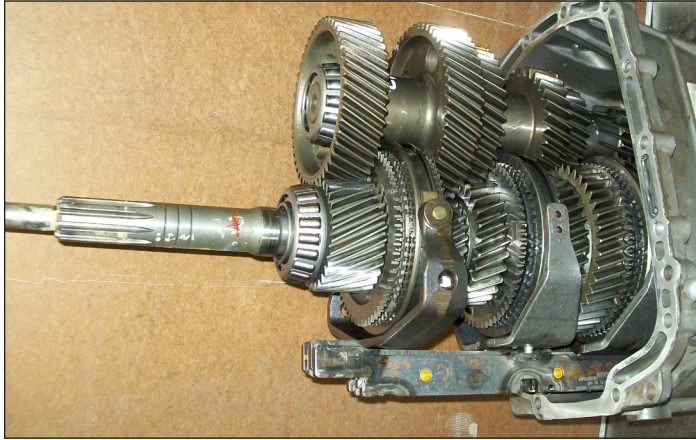
71-24 Rear half of the case with mainshaft and cluster assemblies.

After splitting the case, the internal components remain in the rear case half (photo 71-24). A close-up view shows that the reverse idler gear prevents removal of the gear sets (photo 71-25). The secret to disassembly is to thread a metric bolt (M6 x 1.0 thread) into the end of the shaft, and remove the shaft (photo 71-26). Then, push the gear out of the way and separate the cluster and mainshaft (photo 71-27).

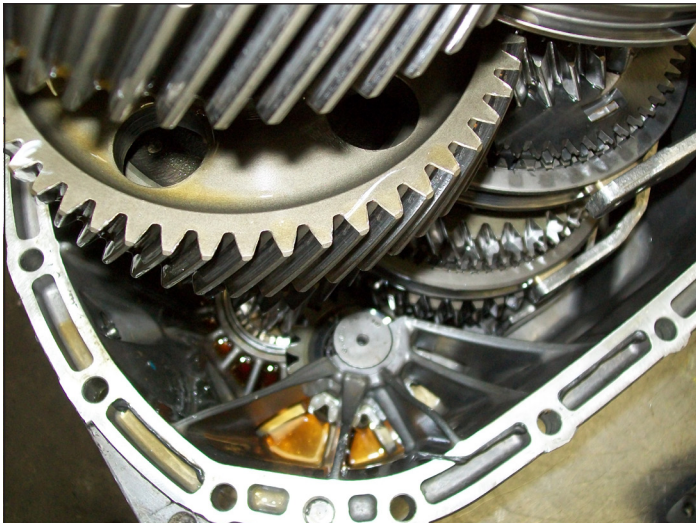
71-25 Close up view of reverse idler gear in rear half of case.

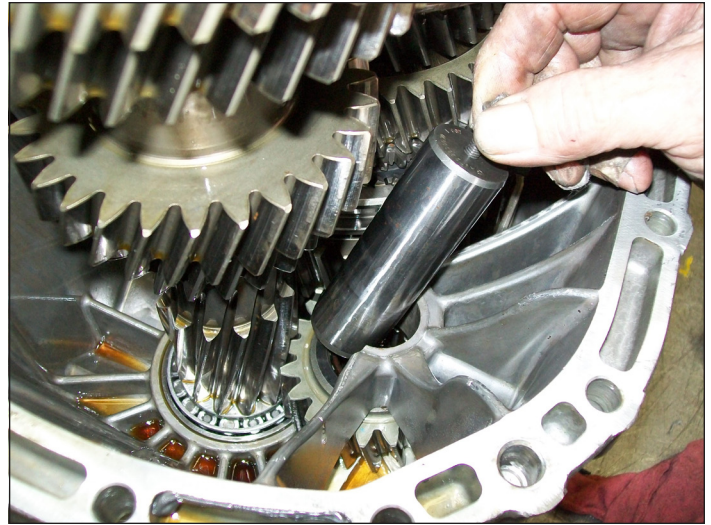
71-26 Removal of idler gear shaft.

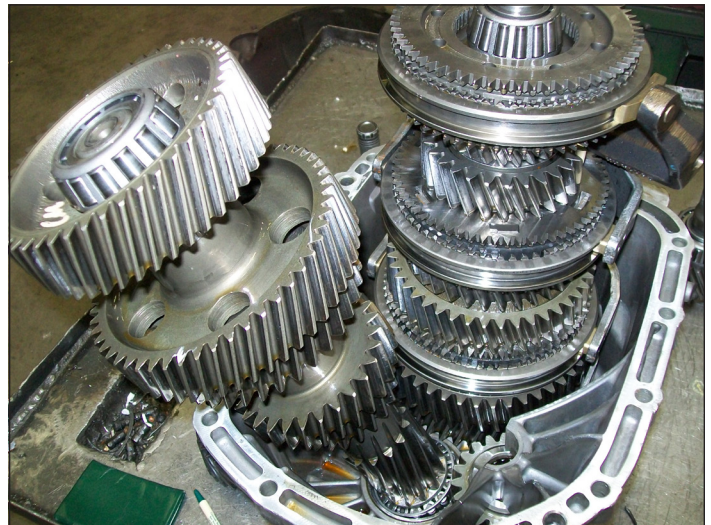
71-27 Separation of cluster and mainshaft assemblies after moving reverse idler gear out of the way.

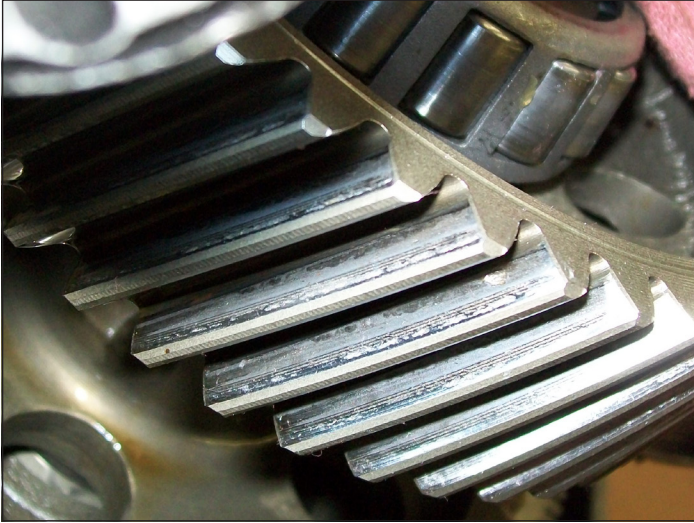
Standard has seen electrolytic pitting of gear teeth (photo 71-29) similar to that seen in automatic transmissions which also have aluminum cases. An extra ground strap such as is sometimes added to automatics may be the cure for this issue. The damage is seen on the leading drive side and edge of cluster and main gear teeth, presumably from an electric field being generated.

71-29 Electrolytic pitting of gear teeth.
