**MANUAL TRANSMISSION
REBUILDS AND UPGRADES**

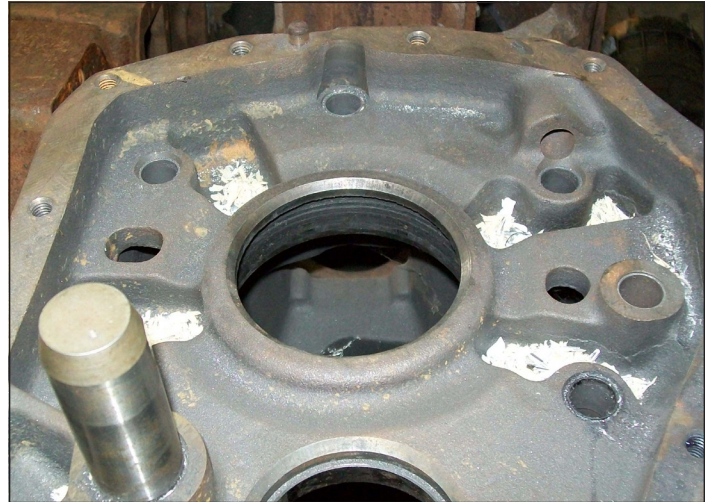
As we discussed in Issue 67 (page 84), the Standard Transmission and Gear Power Lube Package appears to be the real “fix” for this oiling problem. If the rear bearing seizes, the owner often continues driving, and reports later that the transmission “freed up” soon

after experiencing “drag.” In these cases, the bearing is welded to the outer race, which then spun in the main case. The case can be salvaged with a precision machined hole and a specially made sleeve, but the gear case can also be cracked, making the core transmission of little value to a rebuilder. The photo at the top of page 86 of Issue 67 shows this bearing failure. Here is a photo of a main case that the bearing race spun and damaged (photo 71-2).

71-2 NV5600 main case with worn hole for main shaft bearing in the middle of the photo.
